RIPARIAN HABITAT QUALITY AND WATER QUALITY BASELINE SURVEY

SCENIC RIM TRAIL, MAIN RANGE

Prepared for
Spicers Retreats Hotels and Lodges Pty Ltd

File Number: 0435-004b

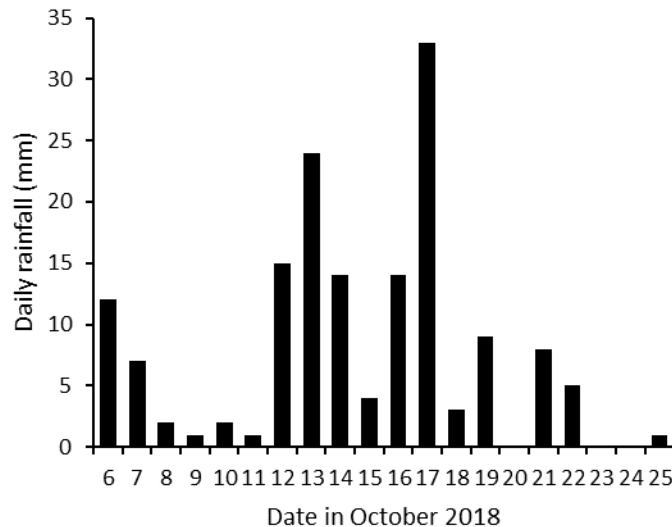
Figure 2. Daily rainfall preceding the survey, as measured at the nearby Mount Castle Alert rain gauge (BoM 2018).

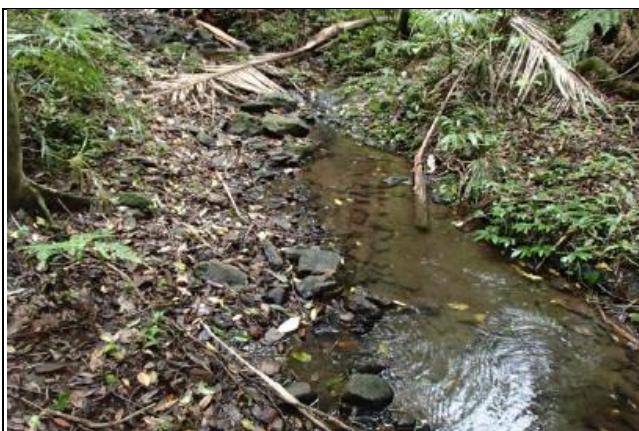
Photo 3.1 Blackfellow Creek within 100m upstream of the proposed crossing point.

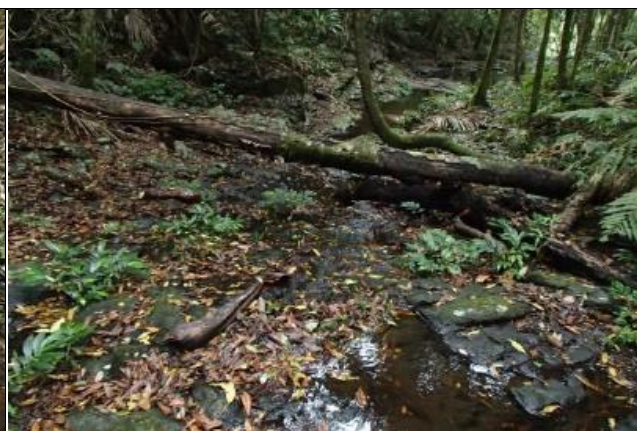
Photo 3.2 Blackfellow Creek within 100m downstream of the proposed crossing point.

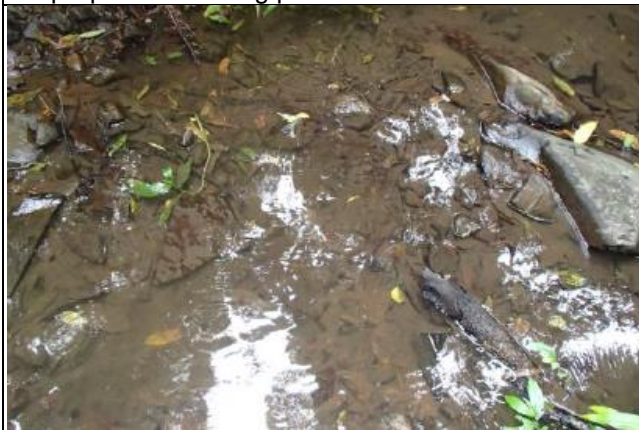
Photo 3.3 Stable streambed with a range of sediment sizes and limited fine sediments.

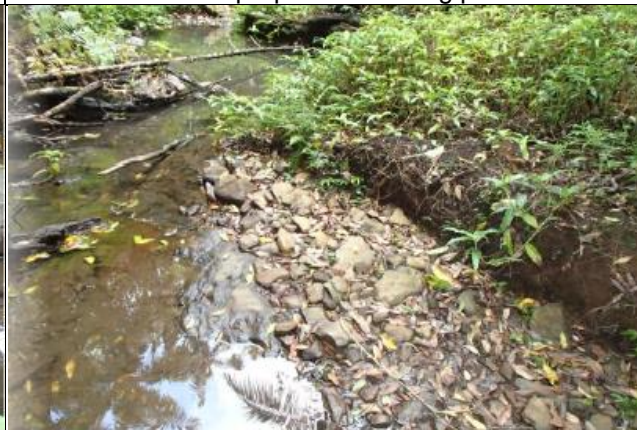
Photo 3.4 Recent erosion on a vegetated sidebar immediately downstream of the proposed crossing.

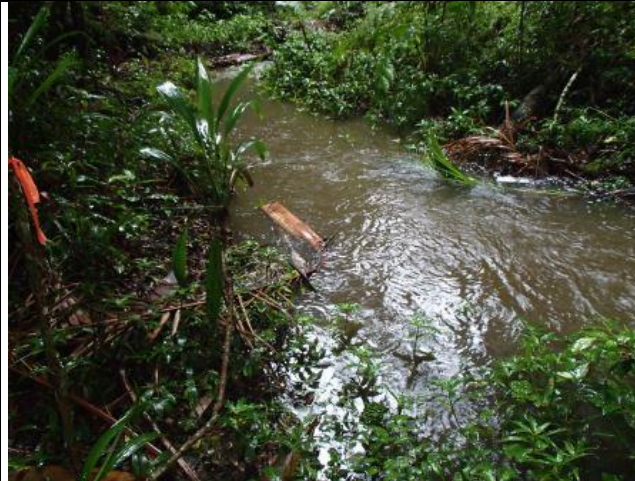
Photo 3.5 Upstream from the proposed crossing point on Blackfellow Creek during high flow conditions on 21 March 2017.

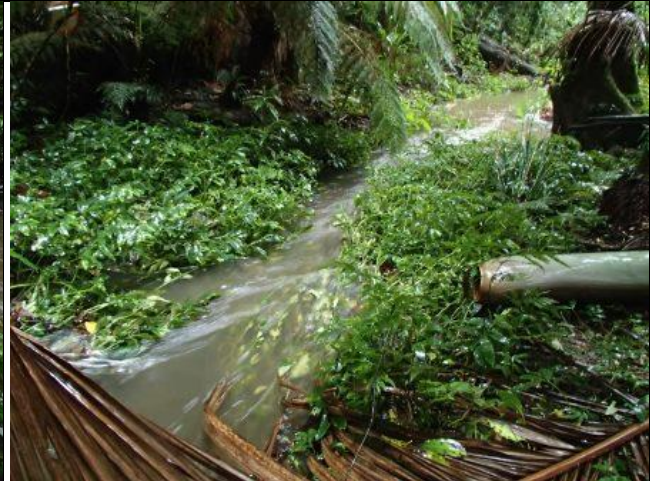
Photo 3.6 View of the proposed crossing point of Blackfellow Creek looking downstream during high flow conditions on 21 March 2017.

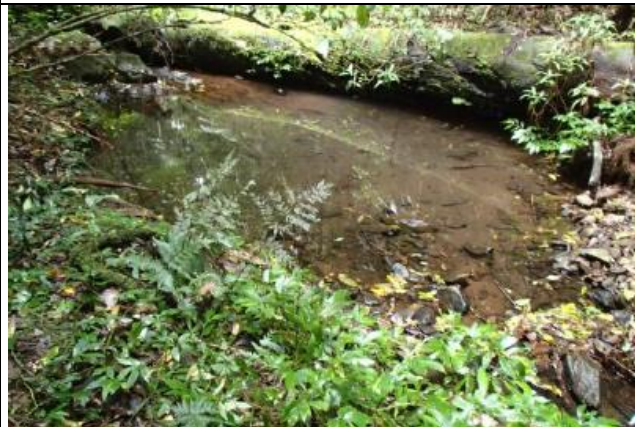
Photo 3.7 Upstream from the proposed crossing point on Blackfellow Creek during base flow conditions on 25 October 2018.

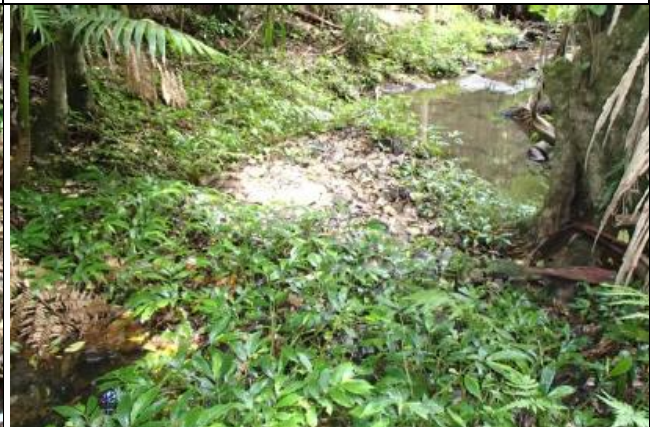
Photo 3.8 View of the proposed crossing point of Blackfellow Creek looking downstream during base flow conditions on 25 October 2018.

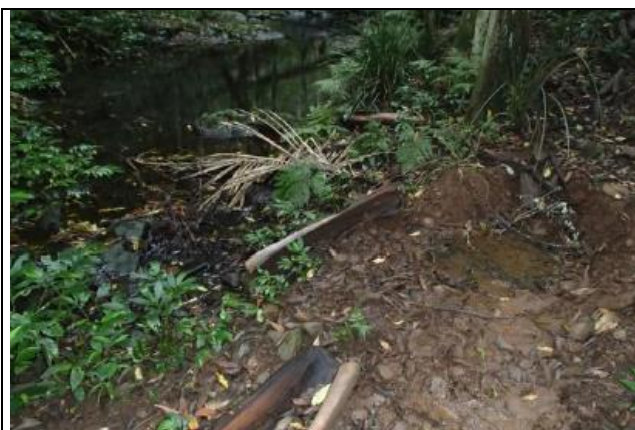
Rainforest Spinach, the predominant groundcover along the stream banks is a weak-stemmed herb that is highly sensitive to trampling i.e. trampling impacts are readily identifiable and immediately apparent. There was no evidence of groundcover vegetation trampling either upstream or downstream of the proposed crossing point. Feral pig evidence was detected at a single location on Blackfellow Creek in October 2018, a mud wallow with fresh pig tracks on the creek bank approximately 150m downstream of the proposed crossing point (**Photo 3.9**). During the March 2017 survey there had been no evidence of feral pig along Blackfellow Creek, but there were abundant fresh feral pig diggings just 200m upslope along the Winder Track where ranger staff had installed a pig trap. There had been no evidence of feral pigs in this area during a November 2016 survey, and there was limited evidence of feral pigs along the Winder Track during a survey in June 2018. Domestic cattle were present in the park during every survey since March 2017; however, evidence of recent domestic cattle presence on the Winder Track (scats, tracks) was only detected in October 2018 and there was no evidence that domestic cattle had accessed Blackfellow Creek.

Photo 3.9 Feral Pig mud wallow on the bank of Blackfellow Creek, October 2018.

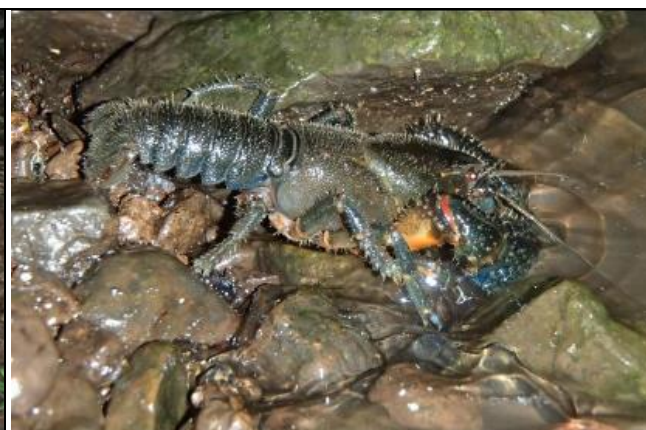
Mt Mistake Spiny Crayfish was observed active on the edge of Blackfellow Creek during the March 2017 survey (**Photo 3.10**), and active crayfish burrows were common along the banks of Blackfellow Creek during both the March 2017 and October 2017 surveys. The total number of active Mt Mistake Spiny Crayfish burrows was 58 burrows within 150m upstream of the proposed crossing point and 18 burrows within 100m downstream of the proposed crossing point, confirming that Blackfellow Creek is an important habitat area for this species. The maximum distance of burrows from the stream edge was four metres.

Photo 3.10 *Euastacus jagara* on the bank of Blackfellow Creek, evening of 20 March 2017.

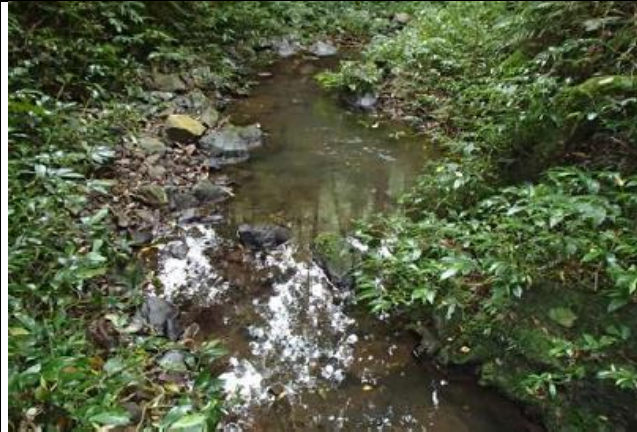
Reference site 2 is located on an unnamed creek 100m upstream of the Lookout Road crossing of the creek, approximately 0.6 km south of the Mt Castle Lookout car park. This creek is of similar size and character as Blackfellow Creek (**Photo 3.11**). There had been extensive browsing of Rainforest Spinach and pugging of softer creek banks (**Photo 3.12**) by recent domestic cattle activity along this creek as also evidenced by 10 fresh dung piles within the first 100m along the bed of the creek.

Photo 3.11 Reference site 2, October 2018.

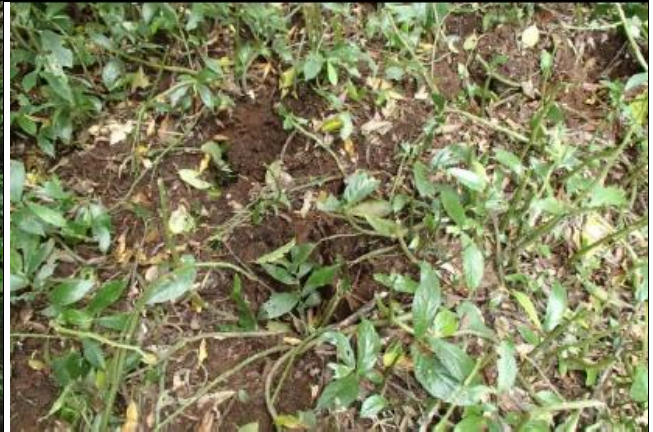
Photo 3.12 Browsing and pugging of creek banks by cattle near Reference site 2.

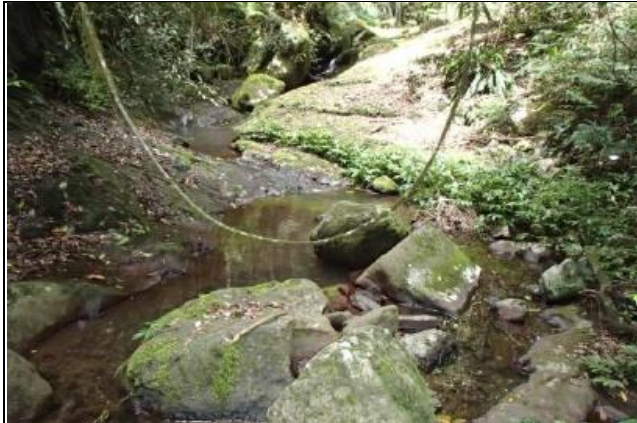
Photo 3.13 Dalrymple Creek within 100m upstream of the proposed crossing point.

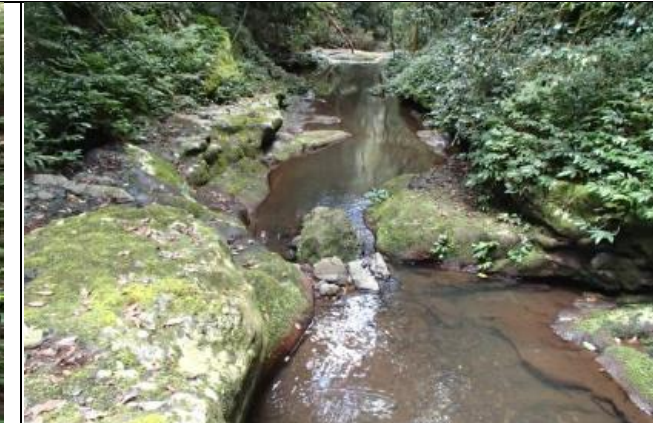
Photo 3.14 Dalrymple Creek within 100m downstream of the proposed crossing point.

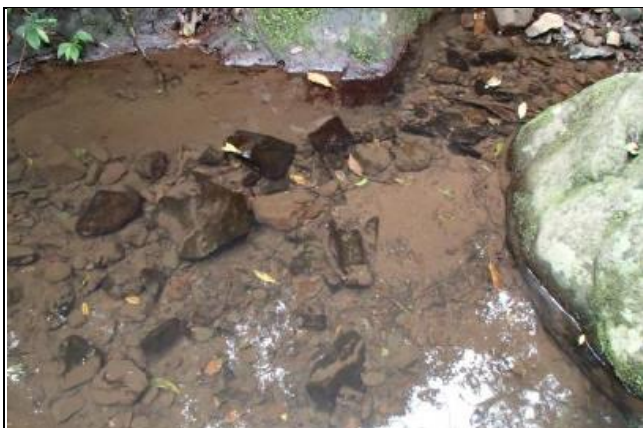
Photo 3.15 Stable streambed with a range of sediment sizes and limited fine sediments.

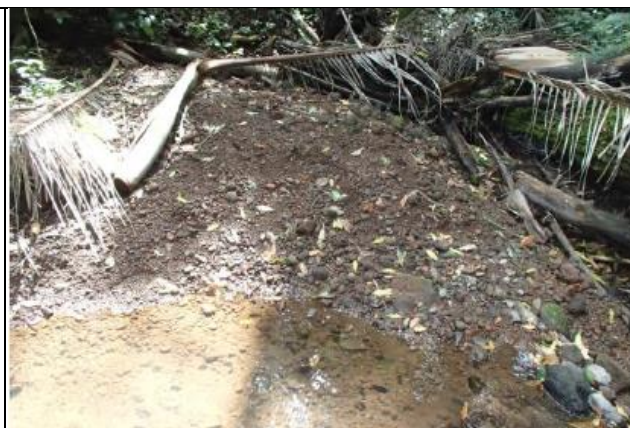
Photo 3.16 Coarse sediment accumulation behind a log obstruction upstream of the proposed crossing point.

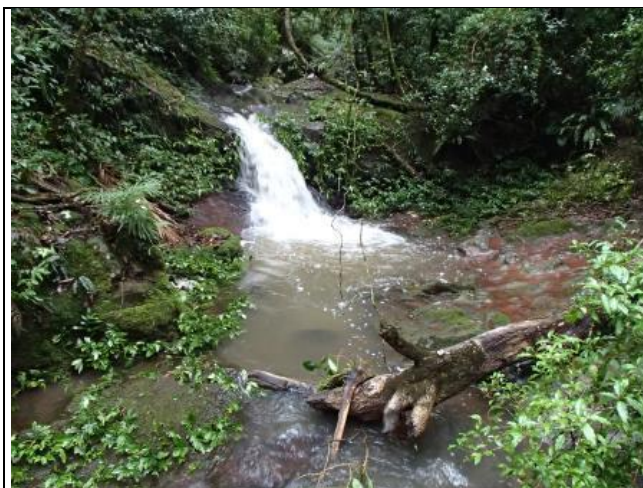
Photo 3.17 View upstream from the proposed crossing point (rock platform at centre of photo) of Dalrymple Creek during high flow conditions on 21 March 2017.

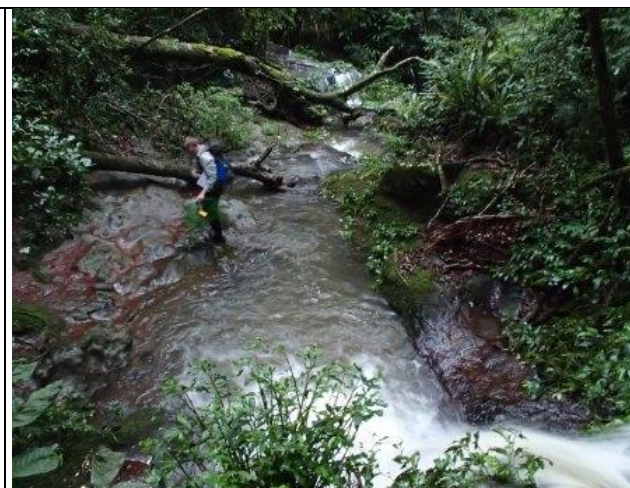
Photo 3.18 View downstream from the proposed crossing point (at centre of photo) on Dalrymple Creek during high flow conditions on 21 March 2017.

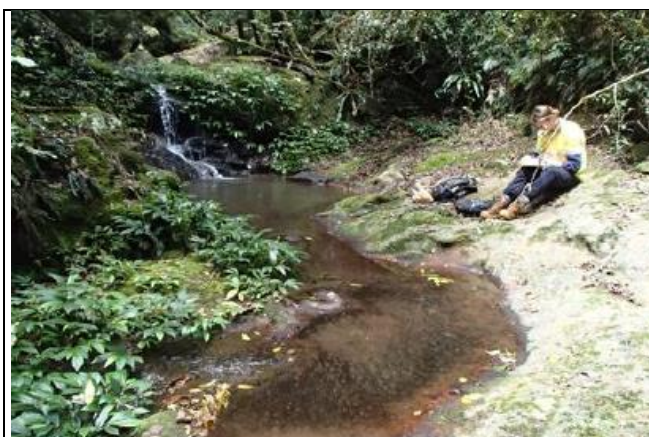
Photo 3.19 Upstream from the proposed crossing point on Blackfellow Creek during base flow conditions on 25 October 2018.

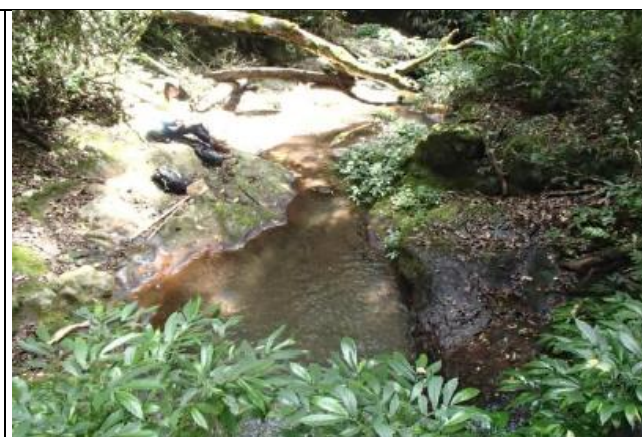
Photo 3.20 View of the proposed crossing point of Blackfellow Creek looking downstream during base flow conditions on 25 October 2018.

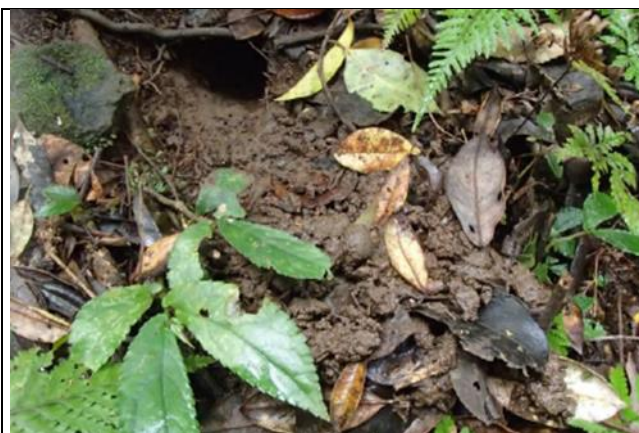
Mt Mistake Spiny Crayfish were observed active at the entrances of active burrows on Dalrymple Creek during the March 2017 and October 2018 surveys. The total number of active Mt Mistake Spiny Crayfish burrows was 28 burrows within 100m upstream of the proposed crossing point and 3 burrows within 100m downstream of the proposed crossing point, confirming that Dalrymple Creek is an important habitat area for this species. The paucity of burrows along the downstream section is likely a consequence of the greater surface area of exposed bedrock and fewer earth banks. The maximum distance of burrows from the stream edge was two metres.

Photo 3.21 *Euastacus jagara* burrow on the bank of Dalrymple Creek, with recently dug out material.

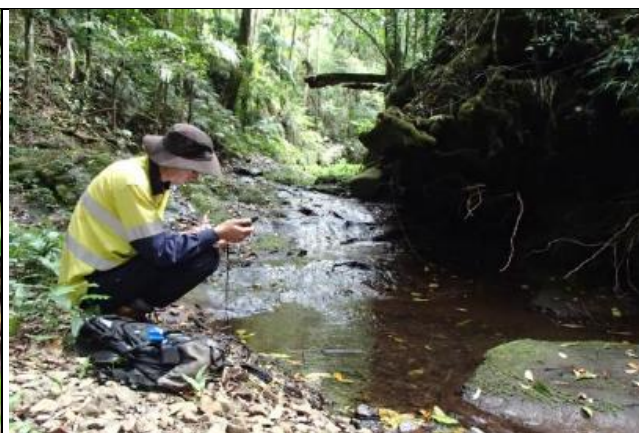
Reference site 4 is located on a tributary of Dalrymple Creek, approximately 100m upstream of a crossing of the creek by the Cascades Circuit public walking track, which continues to cross the tributary several times further upstream. This creek is of similar size and character as Dalrymple Creek (**Photo 3.22**), with no evidence of disturbance.

Photo 3.22 Reference site 4, October 2018.
