# **Community and Stakeholder Engagement Strategy**

## **Community and Stakeholder Engagement Strategy – Scenic Rim Trail**

## Scenic Rim Trail Soils Review

**Winder Management Road (disused  
section of a former logging road)**

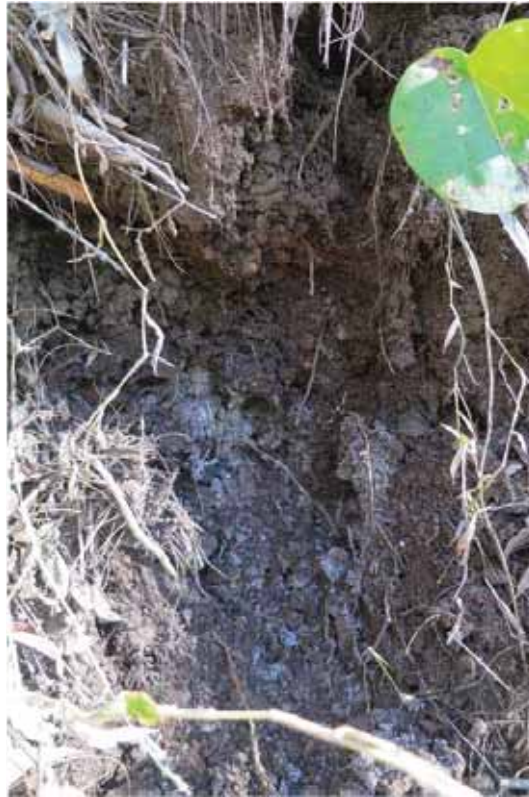
Field investigations showed that Dermosols (Figure 3.3) and Ferrosols are the dominant soil types within the Project area. Soil thickness varies from few centimetres on hill crests (Figure 3.4) to up to 2 m on lower slopes and valleys. Discrete surface rocks, ranging in size from cobbles to small boulders are abundant in many areas, on hill crests as well as on slopes.

**Figure 3.3** Exposed profile of a Dermosol along a track cutting

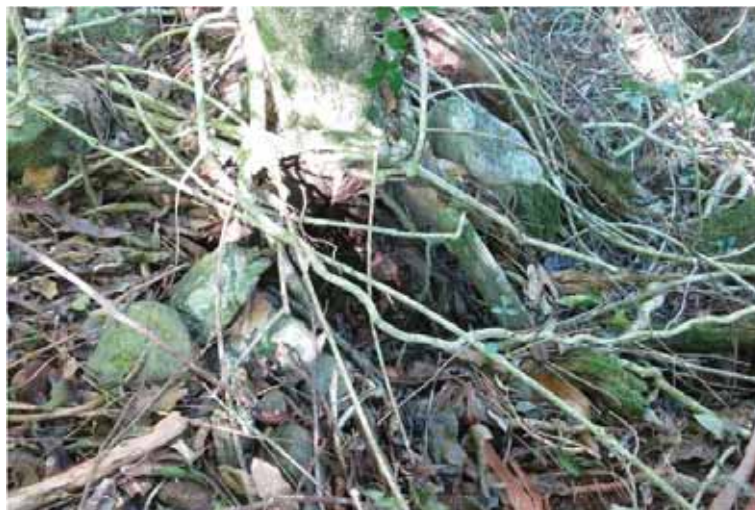
**Figure 3.4** Exposed roots after recent soil disturbance demonstrate thin soils on hill crest

Along the existing trails it is clear that soil depth is limiting and that the vegetation present is well-adapted to these conditions. This is clearly shown by the preponderance of shallow root systems that are exposed along the track and evident in the root balls of fallen trees. It is clear that the vegetation is exploiting nutrients from the deep litter layer and rainfall/cloud combing for moisture rather than seeking to send roots into the hard rock layers. Where the weathered zone is deeper associated with some of the highly vesicular basalts and tuffs that were observed, the trees do send down deeper roots and are generally of significantly larger girths and height.

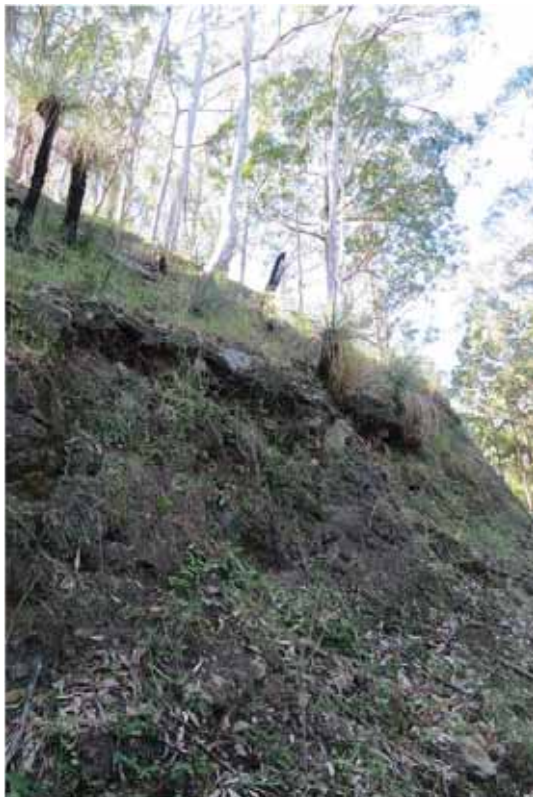
Soil creep on slopes was observed in several locations within the general Project area. This creep phenomenon is generally associated with a thin veneer of soil and accumulated organic matter overlying a layer of small gravels and angular basalt rocks, which in turn overlies weathered or hard rock basalt exposures where observed on slopes and in road cuttings (Figure 3.5, Figure 3.6 and Figure 3.7).

This layer of unconsolidated soil and rock progressively moves downslope due to gravitational forces. These slopes are inherently unstable and activity will be enhanced following wildfires and clearing removing the limited surface protection and root anchoring value of the vegetation. Some more extreme exposures are associated with landslips. The risk of material movement is often enhanced through the fact that the material below the rock layer may not be a beneficial rooting medium (thin soil over bedrock, strongly weathered bedrock etc.) and also functions similar to ‘ball-bearings’ as there is no integration with the underlying weathered or hard rock layer. Fallen boulders were also present in the general area.

**Figure 3.5** Soil creep occurring on several slopes along tracks in the general area of the Project

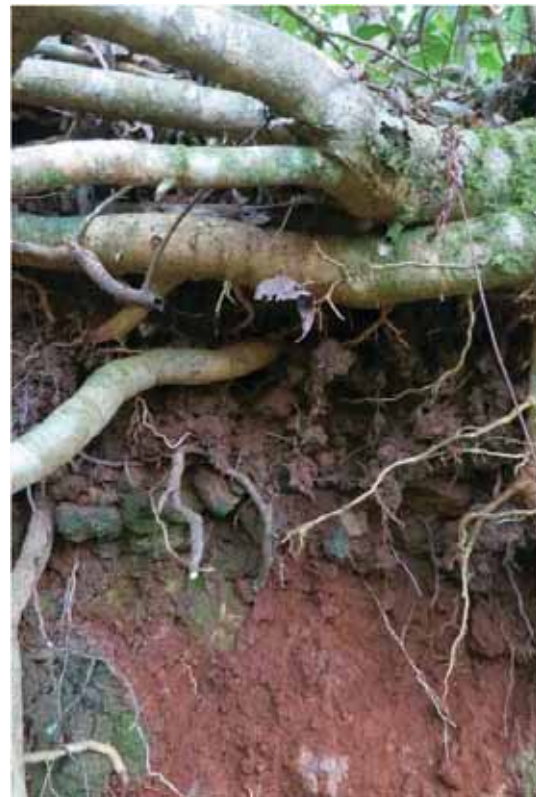
**Figure 3.6** Close up of soil creep. A thin layer of soil and organic matter overlying a layer of rocks over thin soil over strongly weathered basalt

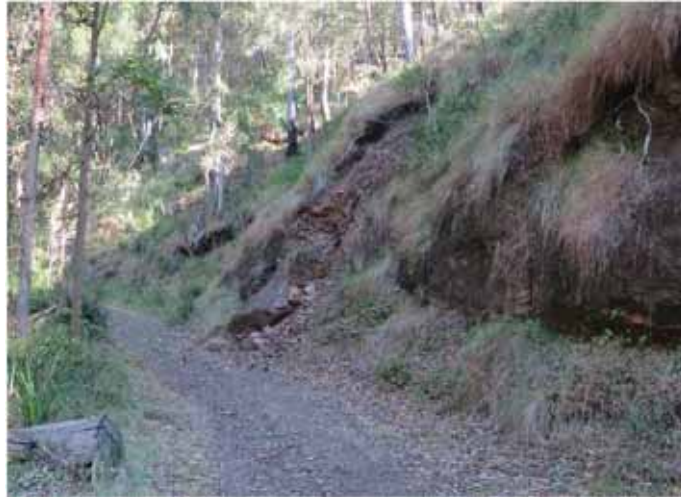
**Figure 3.7 Rockfall in general Project area**

Landslips were also observed along existing former logging tracks where road cuttings subtend steep overlying slopes and recent rainfall had lubricated the contact zone between the overlying weathered zone and the harder underlying rock (Figure 3.7).

Under the current conditions, erosion is predominantly caused by soil creep, as described above, and rockfalls along road or track cuttings. The dense vegetation has to date prevented major occurrences of rill or sheet erosion.

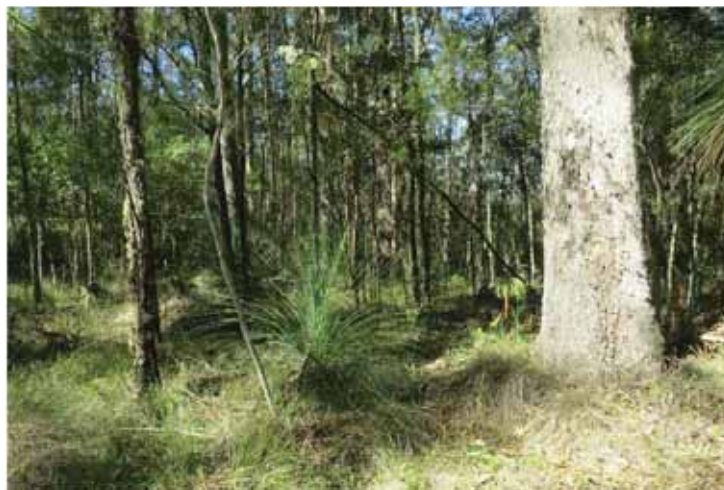
The vegetation changed distinctively from a rainforest to a dry forest on the track from the Mt Castle Lookout to the proposed Amphitheatre campsite and track leading to the proposed Amphitheatre lookout (Figure 3.8, Figure 3.9). The soil type at the proposed Amphitheatre camp site has been identified as predominantly Dermosols with a medium to medium heavy clay subsoil. No Ferrosols were observed in association with this eucalypt forest area and it is likely that these soils are somewhat younger than the Ferrosols having only developed in more humid climates following later exposure of the basalts under the stripped Tertiary surface associated with the Ferrosols.

The heavier clay subsoil layer may preclude the viability of an absorption trench that was initially considered for effluent disposal in this area. The slope leading to the proposed Amphitheatre Lookout may be prone to soil creep where only a thin layer of soil and organic matter overlies a layer of rocks and cobbles on a steep slope. Soil depth on the slope to the valley is shallow and as infiltration into the heavy clay subsoil is likely to be restricted, there is a moderate probability that near surface lateral seepage may occur and initiate slope instability, further encouraging soil creep at this site.

Figure 3.8 Proposed Amphitheatre camp site

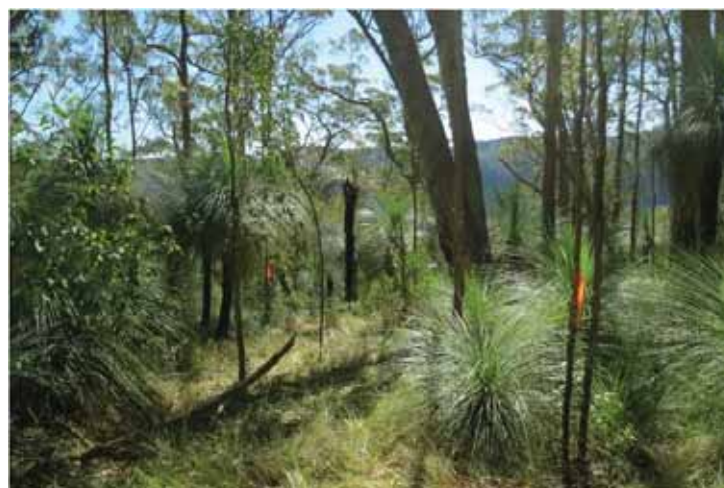
Figure 3.9 Vegetation leading to proposed Amphitheatre lookout

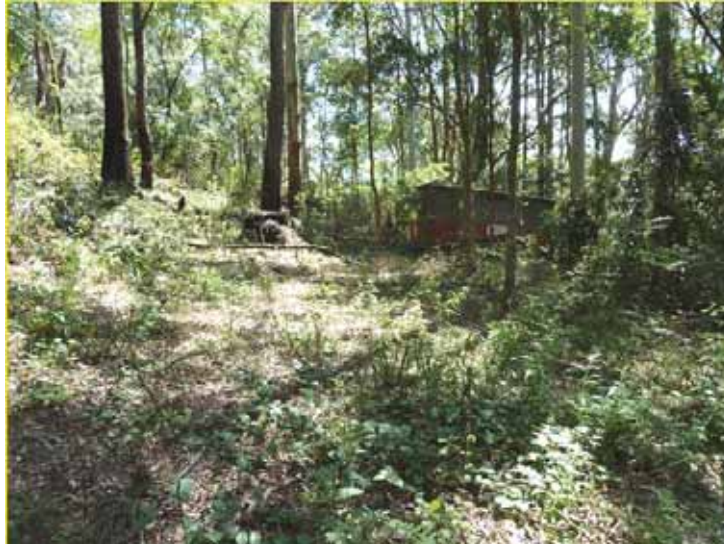
The camp is planned on a flat area which has been constructed on a steep hillslope. The area is associated with historical logging activities and a galvanised iron hut used by former loggers still remains. The area appears to have been affected by levelling due to these historic activities and some material has been pushed towards the Cascade Trail road (Figure 3.10). An approximately 250 m deviation from the Cascade Trail will lead to the new camp site.

**Figure 3.10 Level pad for planned Woodcutters camp**

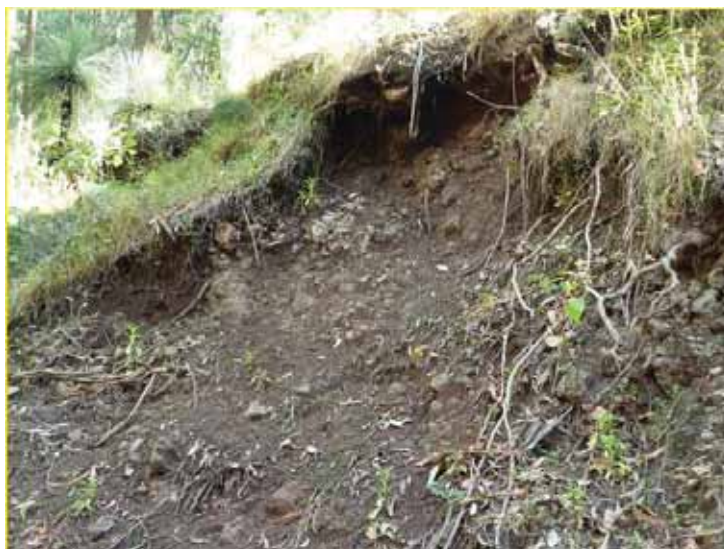
As far as could be determined, the Woodcutters camp site is associated with Dermosols but Ferrosols are visible in a cutting of the established Cascades Trail approximately 100 m up the road from the proposed camp site. The road cutting on Cascade Trail shows signs of soil creep and there is evidence of a recent loss of material due to slippage (Figure 3.11).

**Figure 3.11 Soil creep and possibly recent soil loss at Cascades Trail road cutting**

The soil creep indicates slope instability in the direction of the Cascades Trail and it is suggested that the ecocamp should be established further away from the road towards the historic hut. The area upslope of the proposed camp area has an established New England Blackbutt forest with good herbaceous ground coverage. If not disturbed to any extent, the erosion risk from the upslope area is considered to be low.

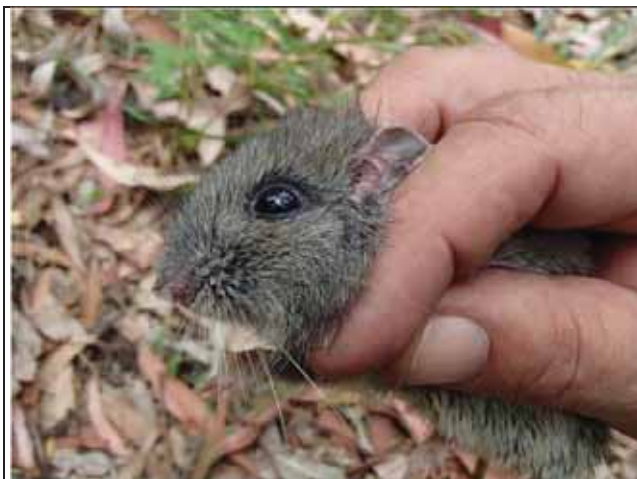
Photo 1. Hastings River Mouse captured upslope of the proposed Woodcutters Ecocamp location, showing the 'Roman nose', black eye-ring and white hairy feet characteristic of the species.

A single Hastings River Mouse (**Photo 1**) was trapped and released on the steep hillside approximately 30 m above the proposed Woodcutters Ecocamp site. The identity of the animal has been confirmed by Dr Ian Gynther (Senior Conservation Officer and mammal expert at EHP's Threatened Species Unit) from photographs taken of the head, tail and feet of the individual before release. This is a significant record since it is the most northerly site that the species has been detected at to date. Previously it has been known to occur only as far north as Cunningham's Gap and North Branch Creek (Ian Gynther, personal communication). The habitat that the individual was trapped in is *Eucalyptus campanulata* (New England Blackbutt) tall open forest that lacked a shrub layer and had a relatively dense groundcover dominated by *Lomandra*

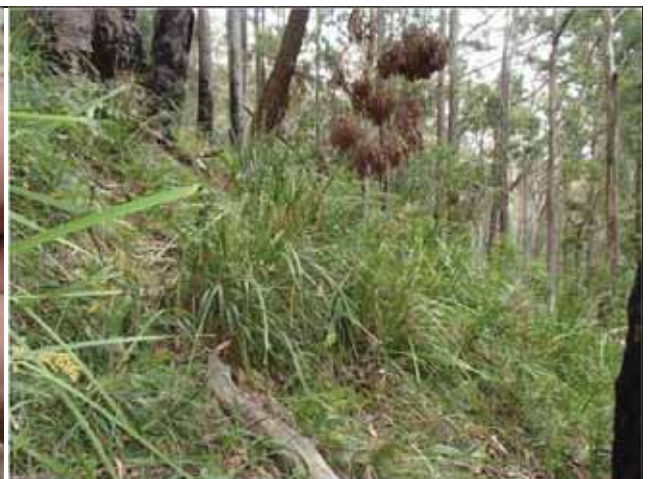
Photo 2. *Eucalyptus campanulata* tall open forest with a dense groundcover dominated by *Lomandra longifolia* at the capture location of Hastings River Mouse.

*longifolia* (Spiny-headed Mat-rush) (**Photo 2**). This habitat is consistent with the known association of the species with upland open eucalypt forests with a dense understorey of grasses, sedges or mat-rushes (NSW DECC 2005, Pyke and Reid 2002, Law *et al.* 2016). Suitable habitat for Hastings River Mouse in the local area comprises the eucalypt forest both upslope and downslope to the west and north of the proposed Woodcutters Ecocamp site, in areas where the groundcover is dense and is dominated by the mat-rush *Lomandra longifolia* and/or the grass *Themeda triandra*. Historical logging at the capture location is likely to have enhanced current habitat values for Hastings River Mouse, since the species' occupancy rates are known to be higher after moderate-intensity logging disturbance and to decline if habitat disturbance (e.g. from moderate-intensity logging or occasional, patchy fire) is excluded for more than 30 years (Law *et al.* 2016). This relationship appears to be mediated to some extent by competition with rats (*Rattus* and *Melomys* species), including Bush Rat, since a strong negative relationship between Hastings River Mouse occupancy and rat abundance has been demonstrated (Law *et al.* 2016). The relatively high abundance of rats at the location where Hastings River Mouse was captured (9 rat captures to 1 Hastings River Mouse capture) suggests that Hastings River Mouse occupancy at the site may be dynamic over time and dependent on periodic habitat disturbance.

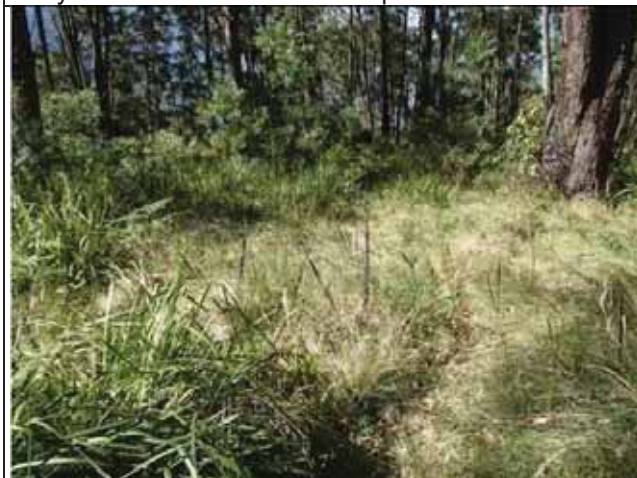
Photo 3. Potentially suitable habitat for Hastings River Mouse in eucalypt open forest with a dense grass and mat-rush groundcover at the edge of rainforest in the Mount Mistake portion of the project area.

Potentially suitable habitat for Hastings River Mouse also occurs in eucalypt forest near the rainforest edge in the Mt Mistake portion of Main Range National Park (**Photo 3**), but not on the freehold properties to the north-west (Lots 144/CC761, 209/CC761 and 180/CC1945) where a history of livestock grazing means that there is insufficient ground cover for the species (**Photo 4**). While no individual was trapped during the survey in the Mount Mistake area, the potential occurrence of the species in this area cannot be excluded since the trapping survey effort (40 trap nights at each of five sites) was less than the recommended survey effort of 400 trap nights per site (NSW DECC 2005). However, the habitat area is already accessible via an existing fire-trail and habitat values for Hastings River Mouse in this area are being degraded by a relatively high density of feral pigs currently active in this area. The proposed hiking trail would therefore have a negligible impact on the species should it occur in this northern section of the project area and would potentially have a beneficial effect through increased feral animal management.

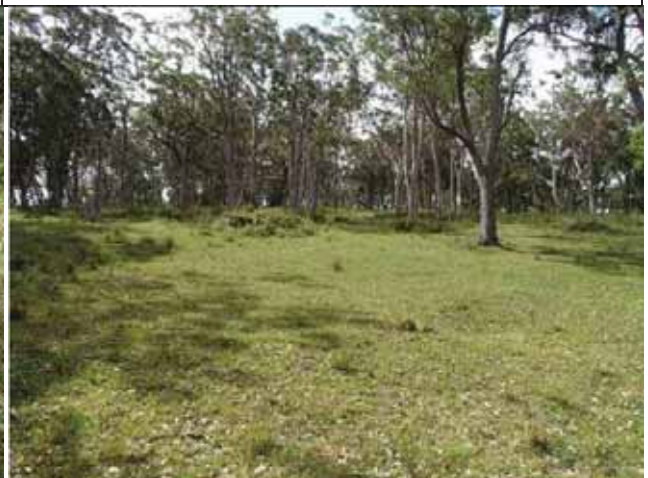
Photo 4. Typical open eucalypt parkland with very short, grassy groundcover on the Thornton to Mount Mistake section of the proposed hiking trail through a freehold livestock grazing property.

Habitats in the project area north of Cunningham's Gap are generally unsuitable for Eastern Bristlebird. In particular, the grassy ground layer in the eucalypt forests in the Mt Mistake portion of Main Range National Park (see **Photo 6**) and on the freehold lots 144/CC761, 209/CC761 and 180/CC1945 (see **Photo 4**) is insufficiently tall and dense to provide suitable habitat for Eastern Bristlebird.

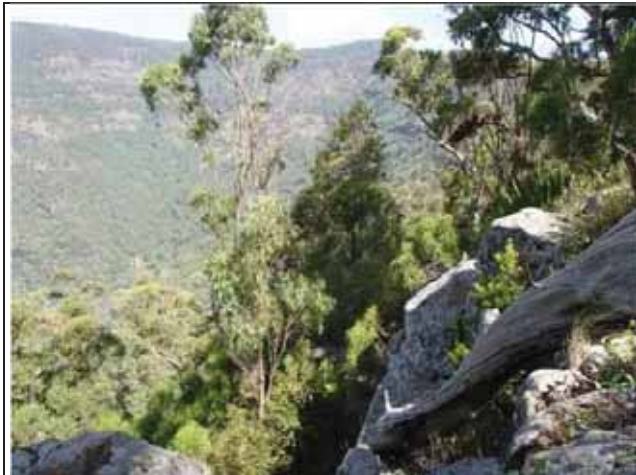
Photo 5. Steep, rocky slopes along the escarpment edge that provide suitable habitat for Brush-tailed Rock-wallaby.

A single Brush-tailed Rock-wallaby was observed at night on the edge of the escarpment approximately 400 m north of the homestead on the freehold property (Lot 144/CC761), but just within Main Range National Park, in the northern section of the project area. The livestock dams on this grazing property that are located within a few hundred metres of the escarpment edge provide water sources for this species, which is likely to occur at many points along the proposed trail in the vicinity of steep, rocky escarpment slopes and cliffs (**Photo 5**). The results of a risk assessment for this species (Table 4.5 of the DPEMP) indicates that potential impacts of the project on this species are likely to be low.

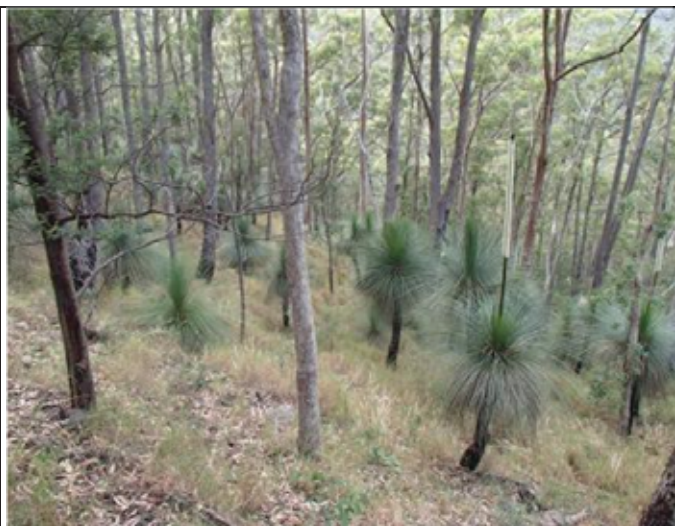
Photo 6. Typical grassy eucalypt open forest in the Mt Mistake portion of Main Range National Park; the *Themeda triandra* grass layer is insufficiently tall or dense to provide habitat for Eastern Bristlebird.

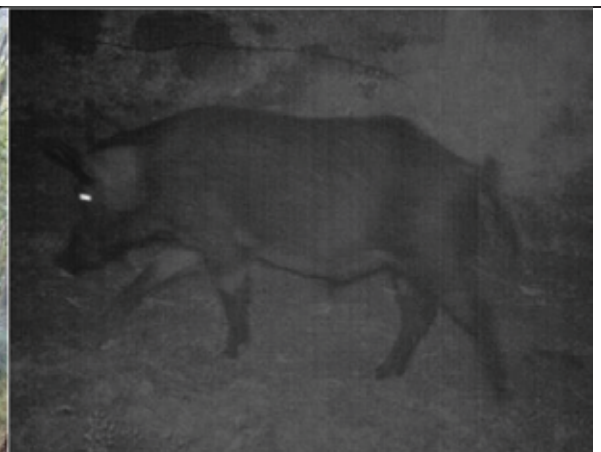
Photo 7. Feral pigs were common in the Mt Mistake portion of the project area and are an important threatening process to the ecological values of Main Range National Park.

The most important threatening process to the ecological values of the project area that were detected during the field survey are: feral pigs (in Main Range National Park and on freehold properties); livestock grazing (on freehold grazing properties); and abundant Bell Miners. Feral pigs appeared to be abundant in the Mount Mistake area (**Photo 7**), both in the national park and on the adjoining freehold properties where livestock dams provide water sources for feral pigs. During the field survey, feral pigs were observed during the day and at night, two of the remote cameras photographed feral pigs, and feral pig diggings were prolific in the area. Evidence of less prolific feral pig diggings was found throughout the project area, including on the escarpment between Cascades and Bald Rock. The proposed contributions of the operators of the Scenic Rim hiking trail to feral pig monitoring and control, particularly in the Mount Mistake area that is more problematic for QPWS to manage feral pigs in, would make an important positive impact on the longer term management of the ecological values of Main Range National Park. Livestock grazing on freehold grazing properties has substantially reduced the height and density of the grassy ground layer in eucalypt forests on freehold grazing properties (see **Photo 4**), which has impacted negatively on habitat values for species that are dependent on a dense, grassy groundcover, including Hastings River Mouse, New Holland Mouse and Eastern Bristlebird.

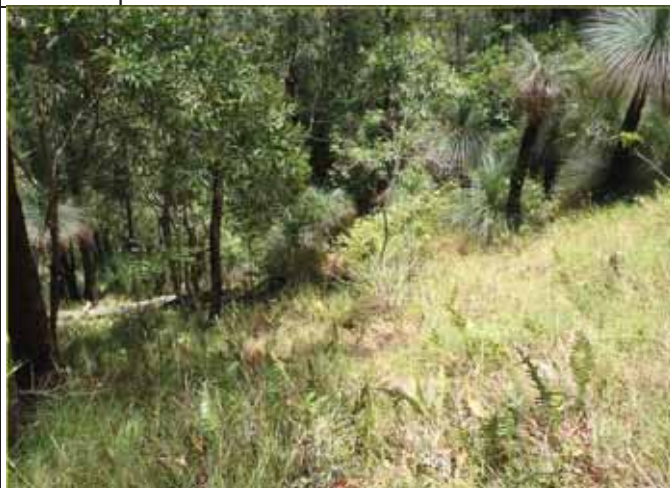
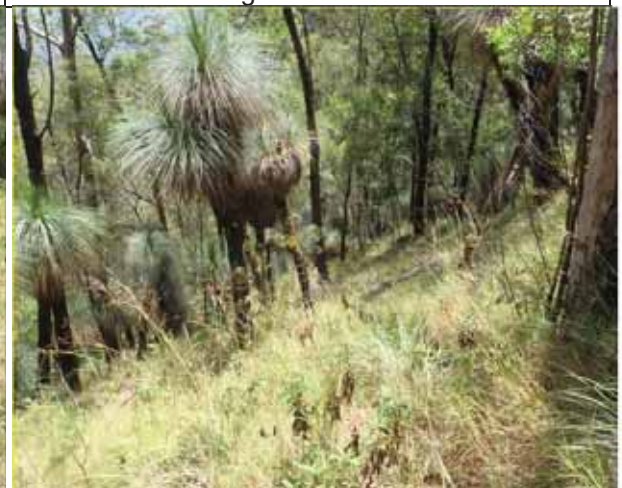
Photos 8 &9 The wetter denser grassy eucalypt open forest in the higher portions of the eucalypt forests within the Mt Mitchell portion of Main Range National Park; where the mix of ground layer vegetation is sufficiently tall and dense to provide habitat for Eastern Bristlebird.

There is habitat for the species on the southern slopes of Mt Mitchell (**Photos 8 and 9**). There are historical records in this location (**Figure 1**), although there have been no records of the species here for over 20 years following a fire event (Gregory, 2007). While the habitat may now be suitable for the species, it is not known if it will or can recolonise.

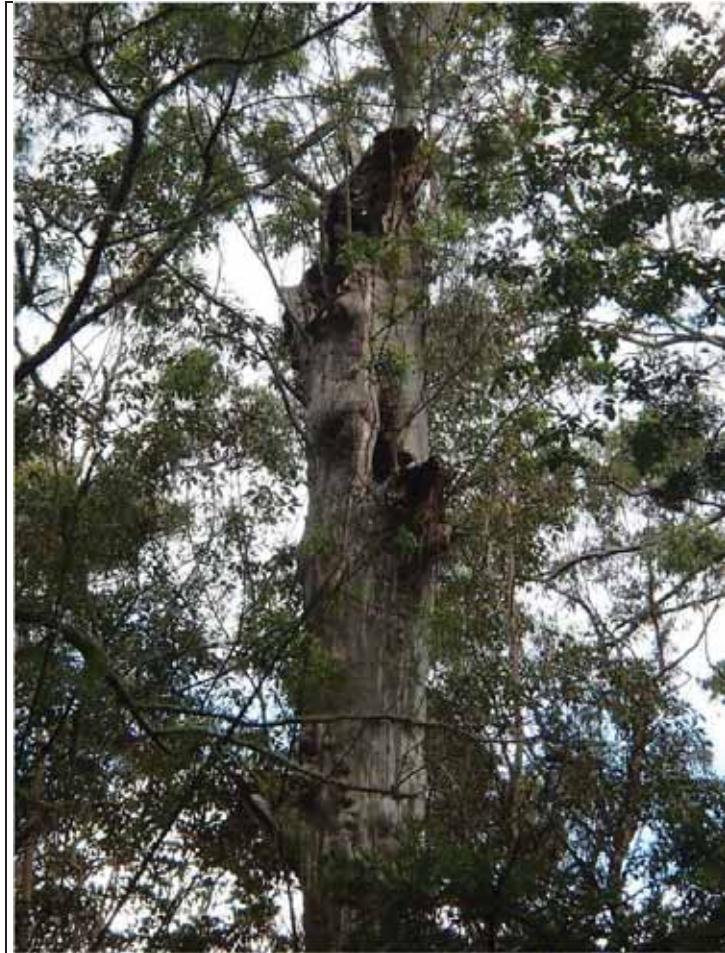
Photo 10. Large, senescent eucalypt tree with large hollows being used as a roost site by Masked Owl near the proposed Amphitheatre Ecocamp site.

A large, senescent hollow-bearing tree located 95 m east of the proposed Amphitheatre Ecocamp site is being used as a roost site by Masked Owl; a bird was heard calling at dusk and dawn (presumably when leaving and returning to the roost), and prey remains were found within the hollow base of the tree. While Masked Owl is not a listed threatened species, this is a locally significant feature for this generally rare species. Potential noise disturbance to the roost site during the construction and operation of the proposed Amphitheatre Ecocamp is likely to be limited though due to the distance of the tree from the camp site and the good number of intervening screening trees.

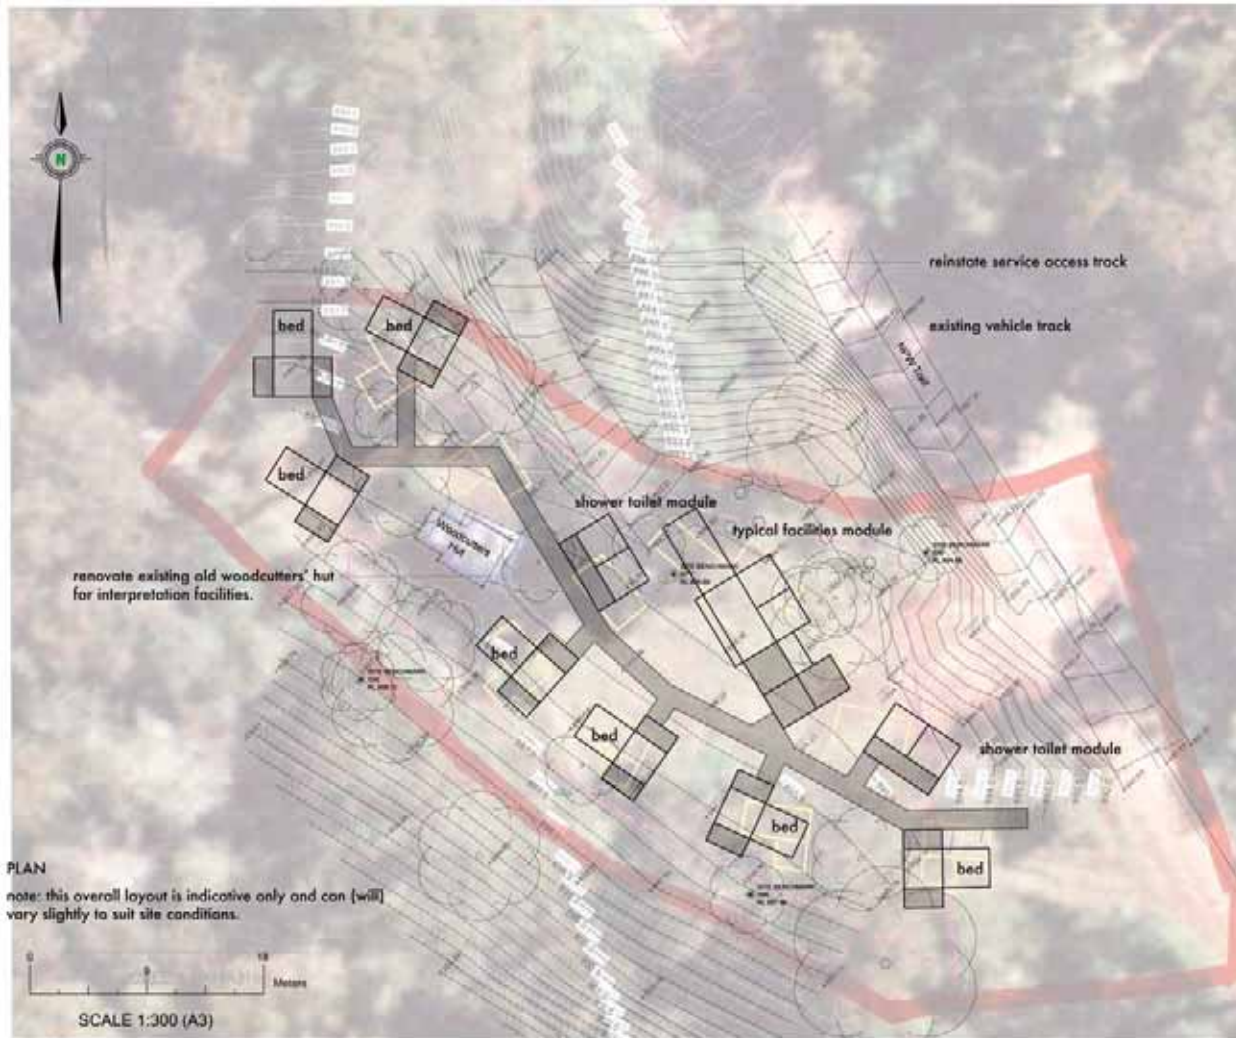
"WOODCUTTER'S" FACILITIES 3.2 21 November 2016 1:300 A3  
preliminary concept sketches: Spicer's Scenic Rim

PLAN  
note: this overall layout is indicative only and can (will) vary slightly to suit site conditions.

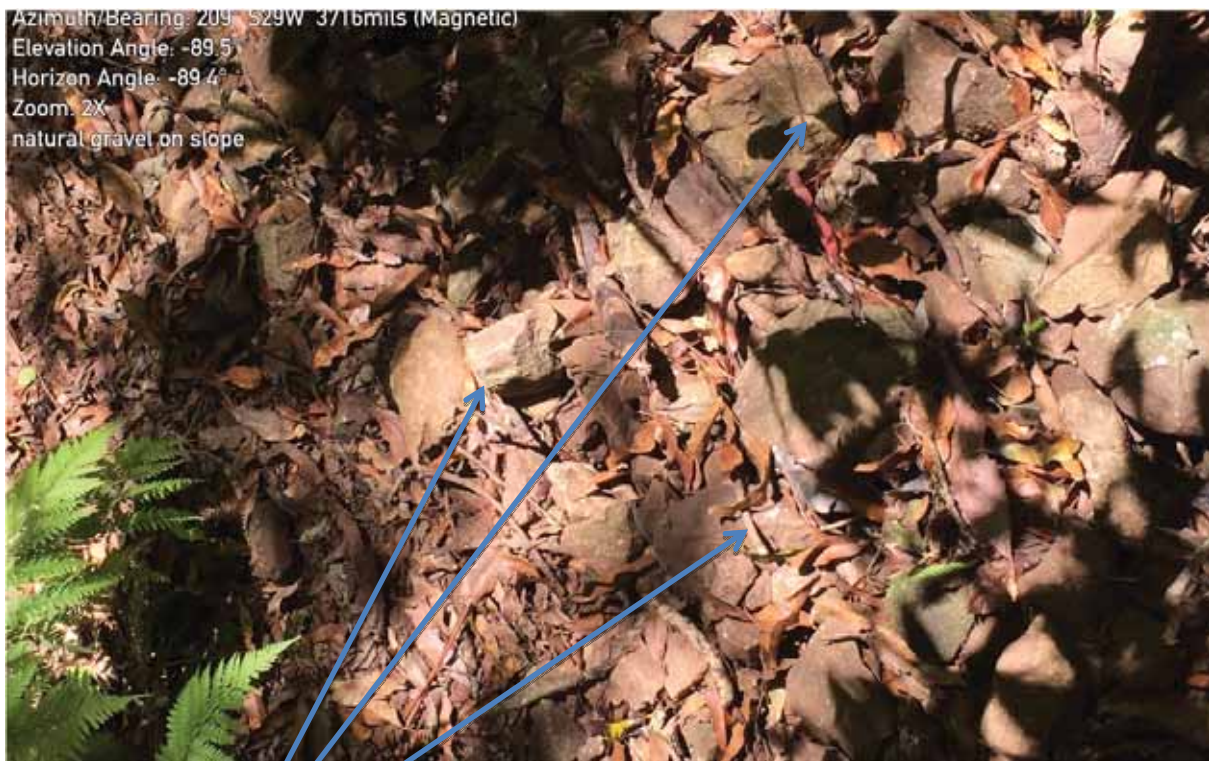
Gravel on steep section of old road

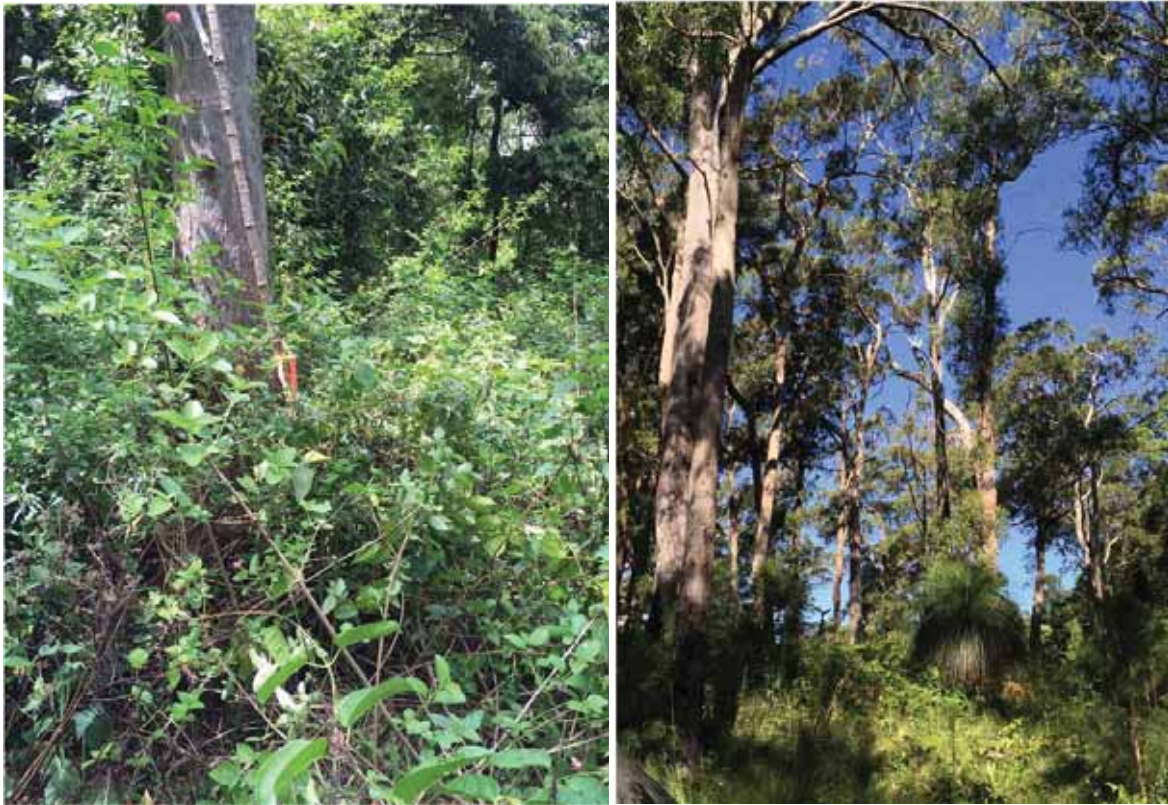
The far northern end of the Winder Management Road emerges from the Rainforest and shows signs of heavy disturbance, and as a result is heavily choked with weeds and fallen timber. This short section of trail (several hundred metres) will require detailed surveying to pick up the exact location of the old trail and use of small excavators to move fallen timber and reform the road. This is a very hot and exposed area and it is planned to divert the walking trail away from this road and into the adjoining rainforest for several hundred metres until the road and the trail can merge in the rainforest. Below are typical examples from this area.

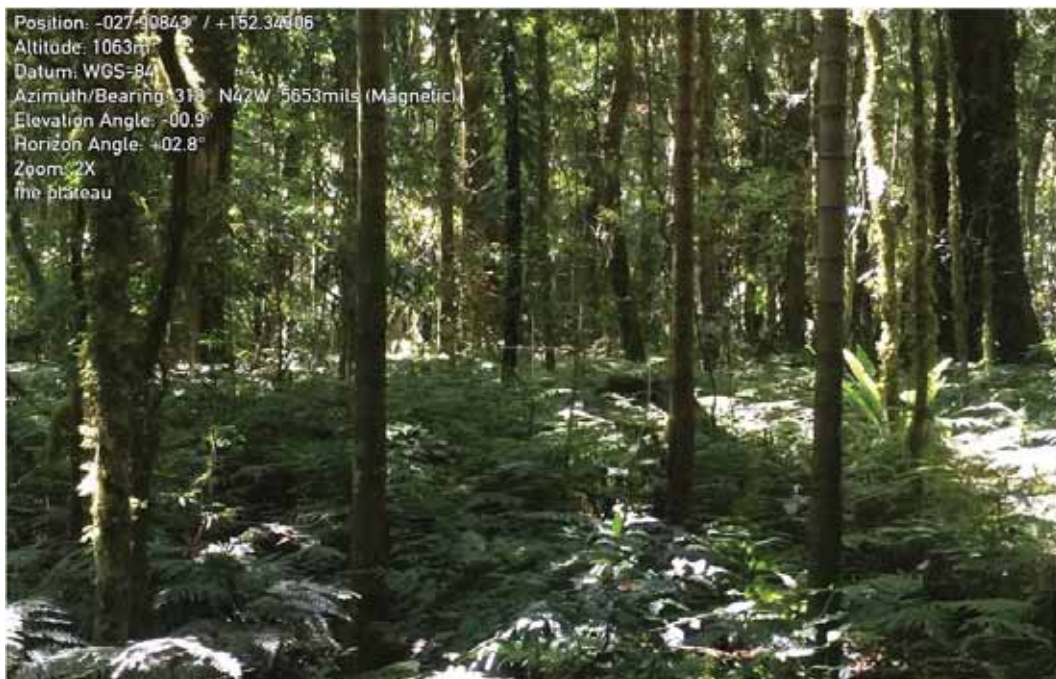
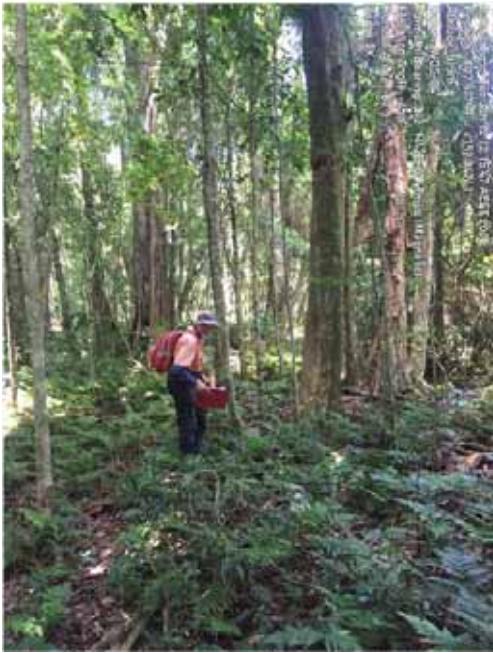
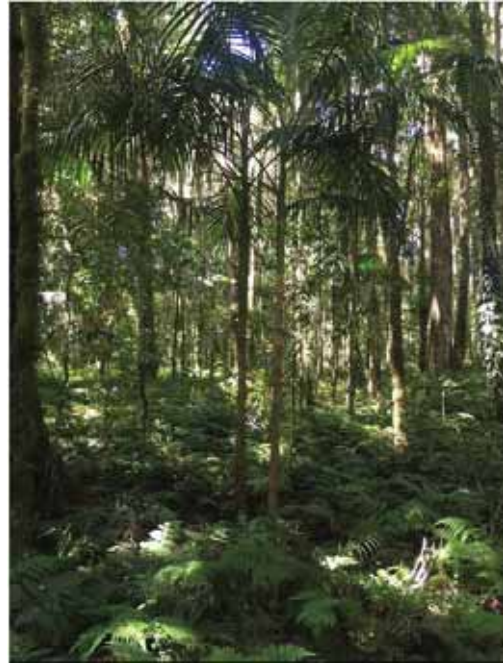
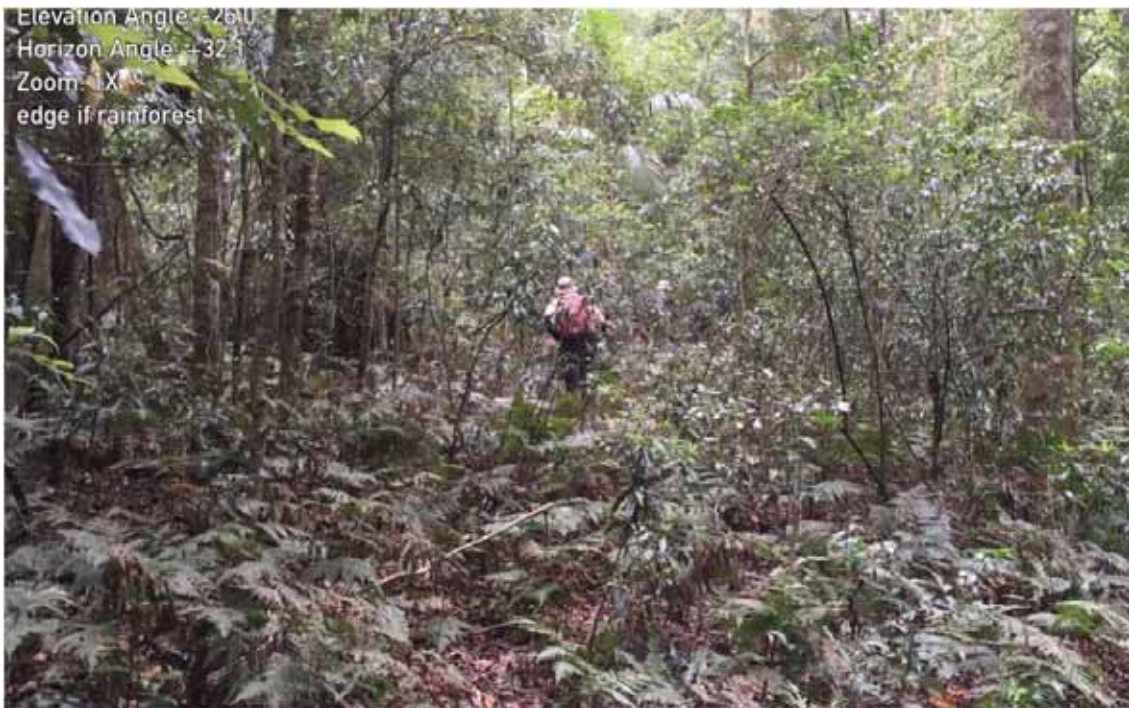
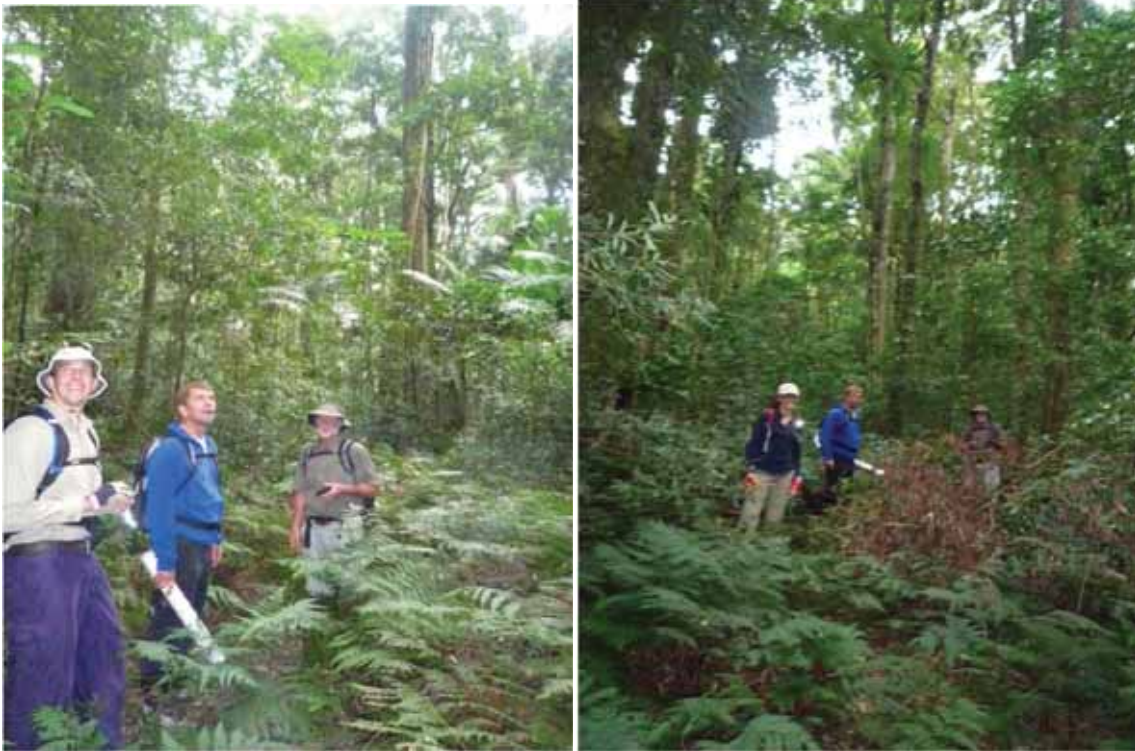
**b) Existing road alignment clearly visible with minimal regrowth and no likely drainage issues**

Significant sections of the trail are relatively flat and the road alignment is clearly visible. This situation occurs for the majority of the road alignment. Roadworks will be limited to any re-shaping of the surface profile, in the case of any small tree removal, stump grinding or removal and filling and compacting with soil will be required. The images below depict examples.

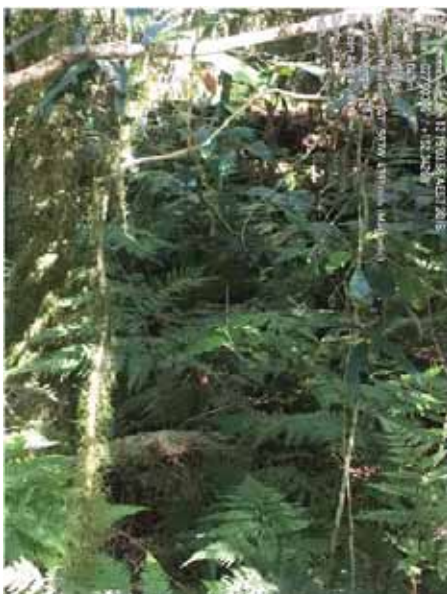
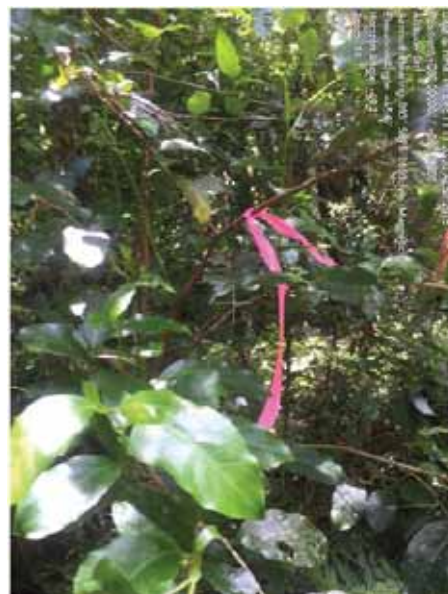
**c) Existing road alignment visible but contains vine and woody scrub regrowth**

There are sections of the old road where the alignment is visible but contains regrowth of some vine, fern and woody scrubs. These sections are similar to b) above but have greater density of regrowth. In these sections roadworks will be limited to any re-shaping of the surface profile, in the case of any small tree removal, stump grinding or removal and filling and compacting with soil will be required. The images below depict examples.

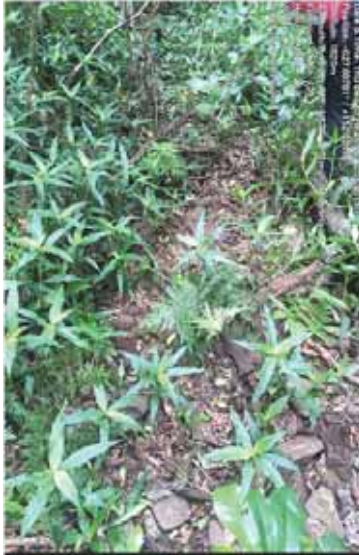
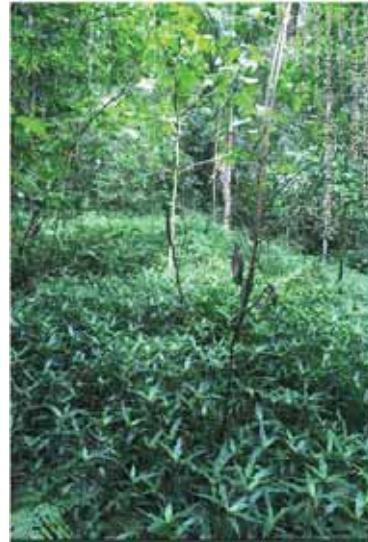
**c) Existing road alignment visible but has drainage issues associated with hollows**

There are a couple of locations where the road has developed depressions in forming wet muddy hollows. These sites will be properly drained and re-profiled to prevent water retention. The images below depict typical examples.

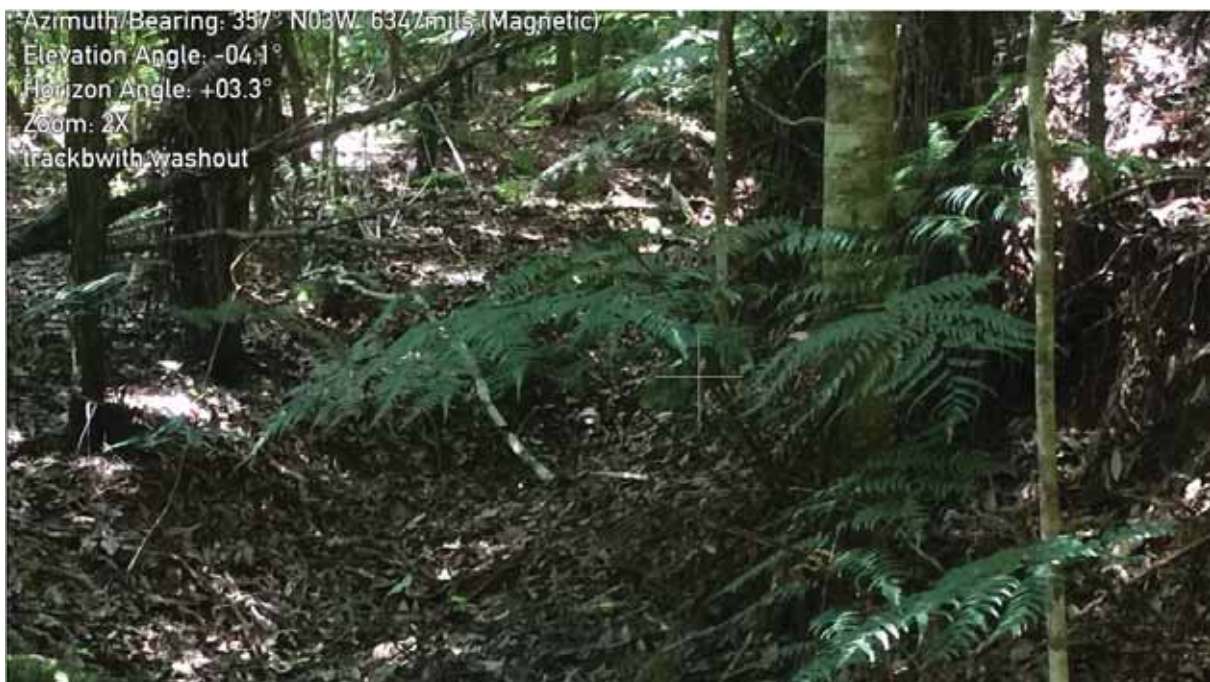
**e) Existing road alignment visible but has drainage issues associated with gradient**

There are a small number of locations with extended sections of quiet steep road that have lost their drainage capacity and require rectification. This will involve re-instating whoa-boys and re-profiling. These sections have some re-growth of ferns and woody scrubs. The image below depicts a typical example.
